LATCH Access Location Warning

2015 Toyota Prius C

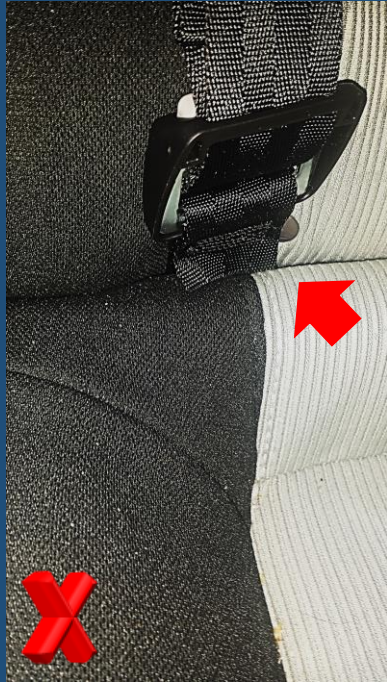
NOT CORRECT

Over the past several months Pro Consumer Safety has received 13 cases where parents had a 2015 Toyota Prius model C vehicle with a child restraint installed using lower LATCH connected through the wrong location to access anchors. Most of these seats had also been installed by CPST's. Make note when using LATCH in Prius C models. As shown, the opening that is horizontal just below the LATCH logo can be misleading where most of the mistakes were found. The proper location for LATCH entry can be accessed upon sliding apart the fabric stitching that is vertical just below the LATCH logo. CarSeatResource@ProConsumerSafety.com

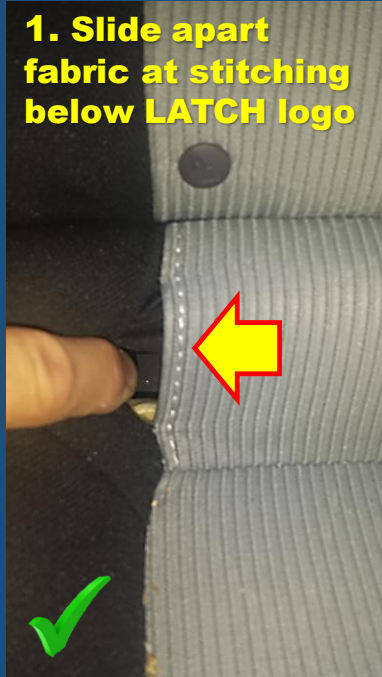
1. Slide apart fabric at stitching below LATCH logo

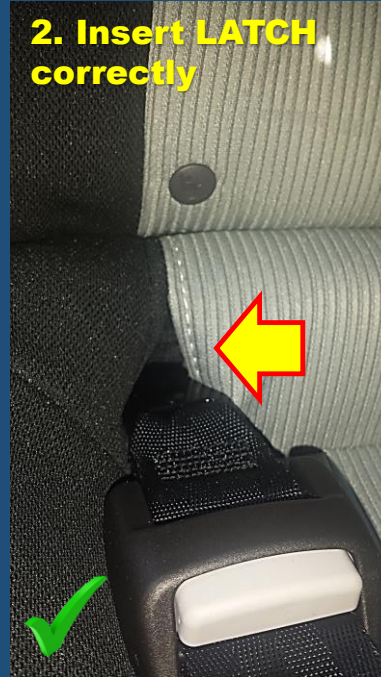
2. Insert LATCH correctly

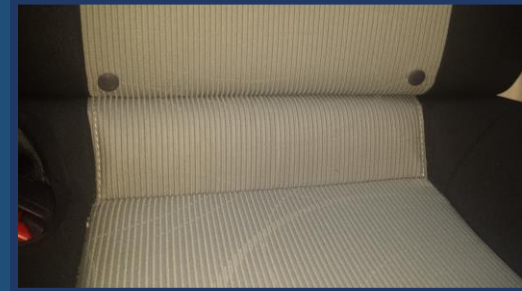
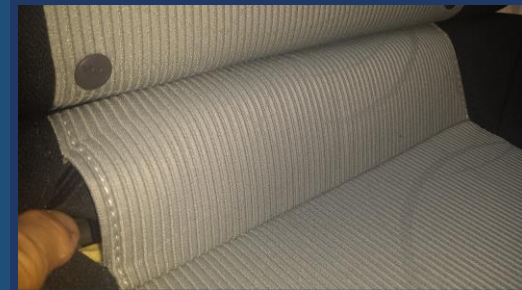
CORRECT
